**REMEDIAL INVESTIGATION REPORT  
VOLUME 5**

**APPENDIX N:  
MIDDLE FORK  
OF LITTLE BEAVER CREEK**

## CHEMISTRY AND ECOLOGICAL INFORMATION MIDDLE FORK OF LITTLE BEAVER CREEK (Sheet 1 of 9)

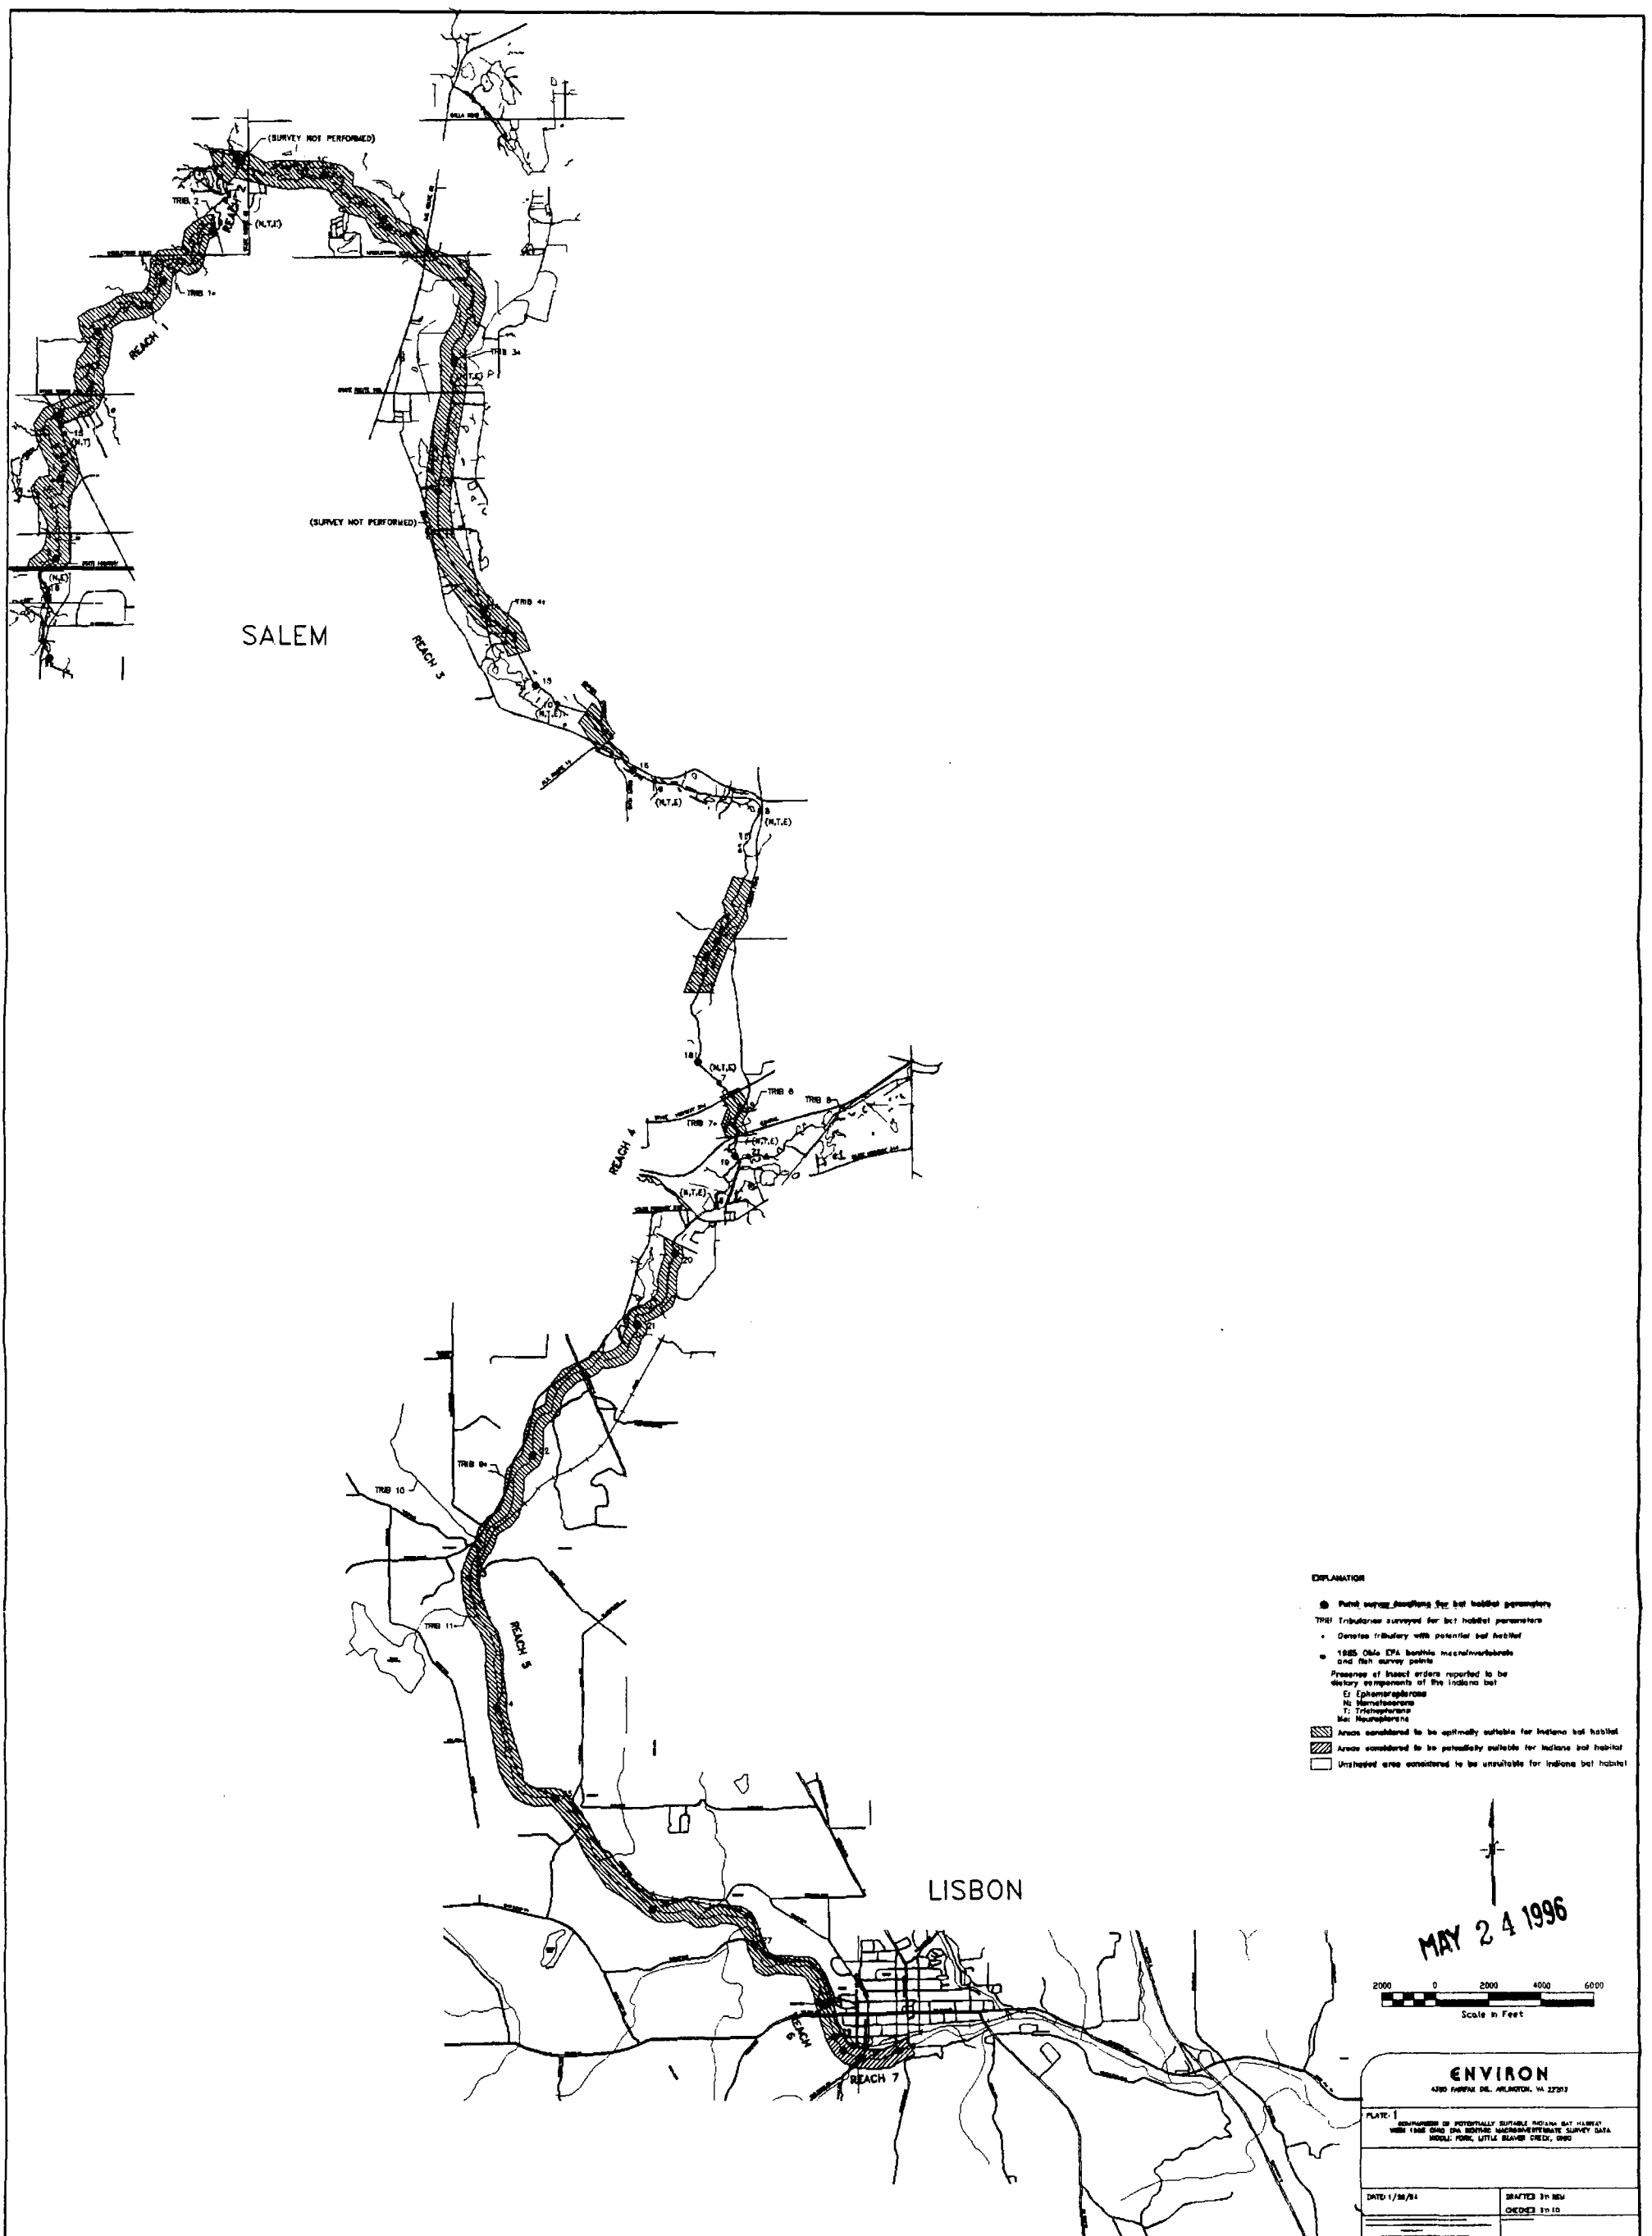
**FIGURE 1**

**SURVEY POINTS, REACH SEGREGATIONS,  
AREAS OF POTENTIALLY SUITABLE INDIANA BAT HABITAT,  
AND OHIO EPA BENTHIC MACROINVERTEBRATE SURVEY RESULTS**
